# 2013 Proceedings

## Unraveling the Mystery: Using Microscopy in a Metallurgical Failure Investigation

Steven A Bradley, Karl W Hagglund, Lily So, Amanda L Stolarski and Benjamin L Tiemens

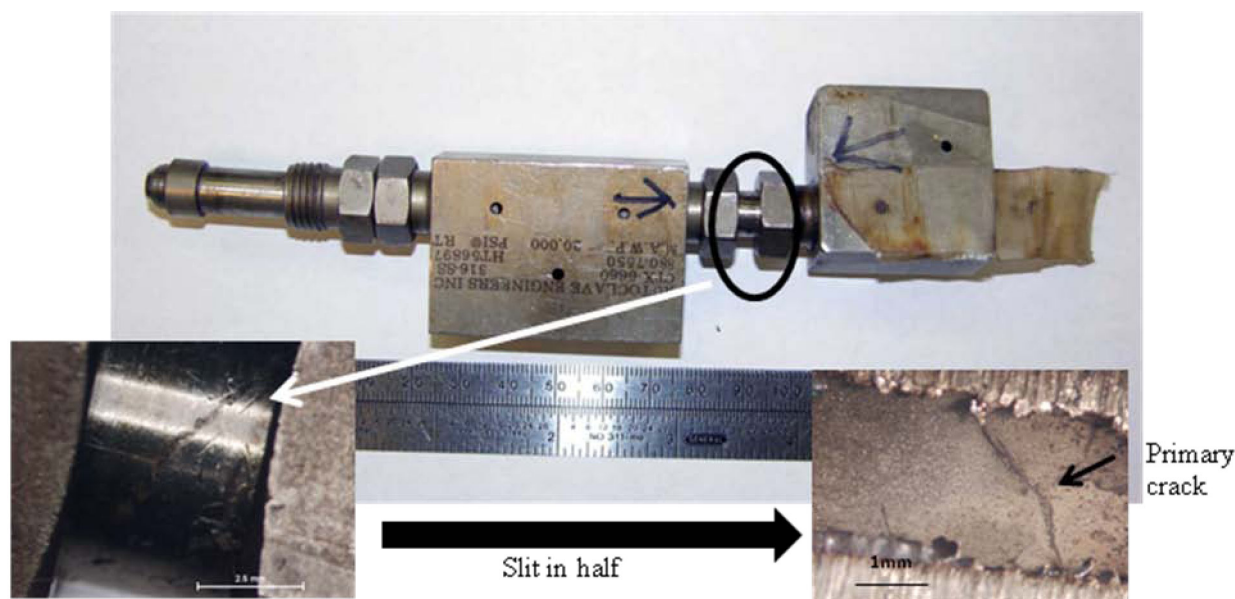
A possible crack was noted on the outside diameter (OD) of the fitting and the tube section was slit to reveal the extent of the cracking on the inside diameter (ID) (Figure 1). The sliced tube section was cut again length wise so that half could be used for metallographic analysis at the presumed initiation site and the other half could be used for SEM fractography.

**Figure 1.** Observed crack on OD and sectioned for viewing on ID; inlet is on right.

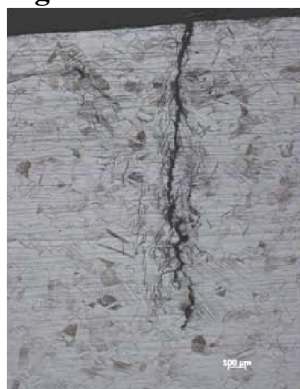
A branched, transgranular crack initiating from the ID was observed that propagated almost completely through the wall of the tube, as shown in the metallographic cross-section of Figure 2. Branching was not extensive, suggestive of high stress Cl stress corrosion cracking. Microstructure was typical of cold working and no sensitization could be found.

The ultimate cause of the failure was the result of Cl stress corrosion cracking. Because of the design and assembly of the fitting, the line was under high torsional stress. Although the Cl was at extremely low concentration, the Cl concentrated at the failed location because of vapor/liquid condensation along with the sulfide corrosion scale providing a concentration site. Change to a fitting connection producing less stress and suitable insulation to prevent vapor/liquid concentration was recommended.

**Figure 2.** Branched transgranular cracking initiating from ID. **Figure 3.** Transgranular fracture surface.

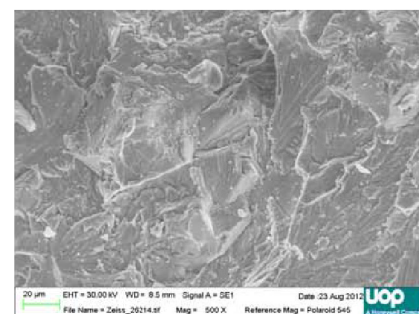
Most of the fracture surface consisted of transgranular shear (Figure 3) with only a small portion exhibiting a dimpled appearance typical of ductile overload. SEM/EDS chemical analysis at the crack initiation site identified the presence of both S and Cl; however, only S and no Cl was found a short distance (200 µm) from the ID. The ID of the tube also showed the presence of Cl and S but no Cl or S was detected at the crack tip. Cl was detected on other parts of the fitting with less noted for the outer block while the outer tube section had no detectable Cl or evidence of cracking.

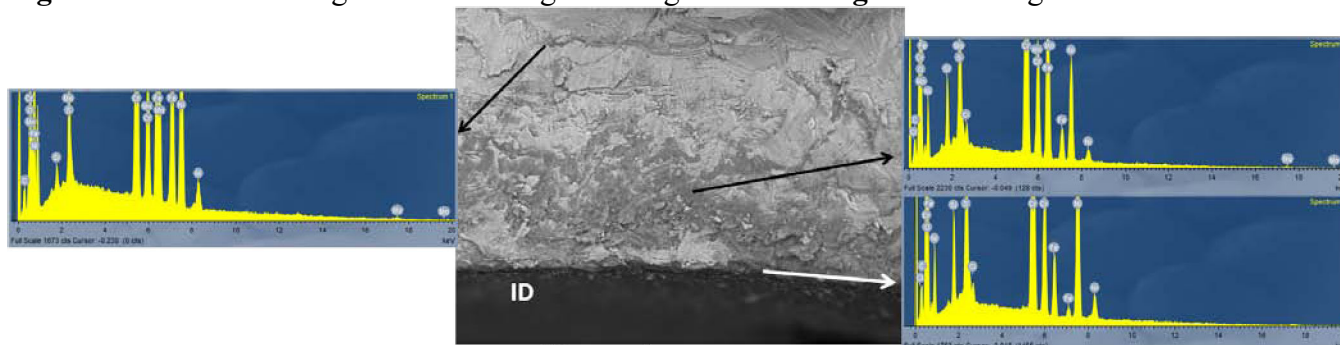
**Figure 4.** At ID of fracture surface Cl is detected and has concentrated in the sulfide scale.
